# REPORT

## THE APPIATSE EXPLOSION DISASTER IN GHANA: AN ANALYSIS OF THE SITUATION A YEAR ON

**January 2023**

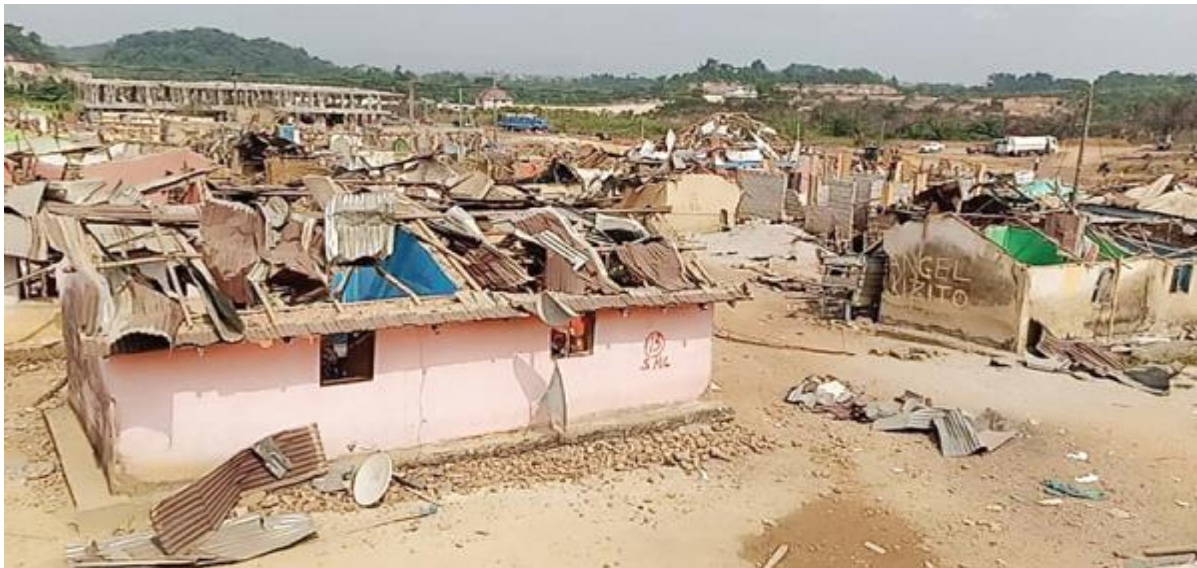
**Figure 1: A picture of Appiatse after the explosion**

The incident as was recounted by the respondents showed that on the 20<sup>th</sup> of January 2022, around 12 noon, a motor bicycle had an accident and skidded about 10 metres and went under a truck travelling on the Takoradi to Kumasi highway through Bogoso at a section in Appiatse. The accident prevented vehicular traffic from crossing that section. Therefore, vehicles from the Bogoso side of the highway toward the Kumasi side and vice versa had stopped. The truck was carrying explosives for a mining explosives services company (MAXAM Ghana Limited). The motor cycle was said to have exploded and caught fire under the truck. Within a few minutes after the accident with the truck, there was an initial small explosion of the motorcycle fuel tank which caught fire under the truck. The accident and the small explosion and fire attracted both community people and passengers in vehicles who were prevented from crossing that section of the road to the scene. At approximately 12:46 p.m. there was a second explosion (Major, caused by explosives on the truck). This was the explosion that caused all the havoc in Appiatse. Some vibrations could be felt in part of Bogoso including the area where the Municipal Assembly is located. At the Bogoso Health Centre for instance, most of the ceiling in the building came down. Figure 1 is a picture of the town after the explosion.

The second explosion caused a crater in the road of about 30 feet deep. The effects of the explosion are still visible about 500 metres away from the blast point. One respondent (Works Department) submitted this on the effects of shrapnel from the blast:

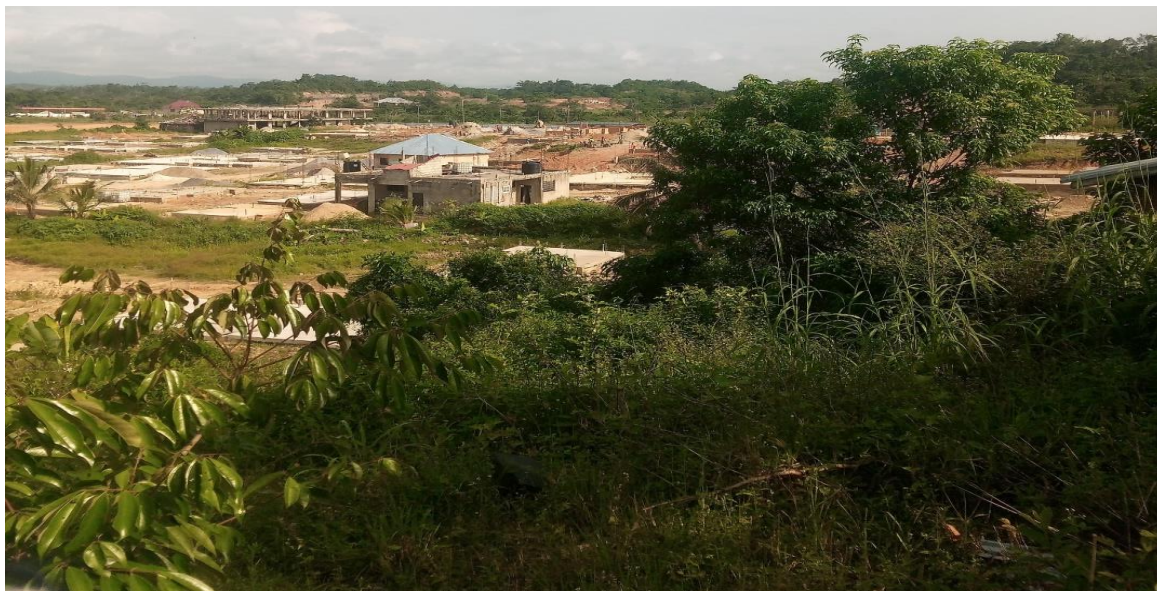
**Figure 2: A picture of the town with reconstruction going on.**

Though the rebuilding process is progressing smoothly, there were a few challenges with the planning stage. The zonal planning of the new community was done in Accra and when the plan was brought to the Municipality, it was realized that a waterway was zoned for residence, so the plan had to be redone at the Municipal level to relocate that portion away from the river. Figure 2 is a picture showing the reconstruction site with the foundations of ongoing buildings.
